Wisconsin Groundwater-Level Monitoring Network Improvement

Open-File Report 2017-04

Project activities: Well Maintenance (Objective 4) and Well Drilling (Objective 5)

July 31, 2017

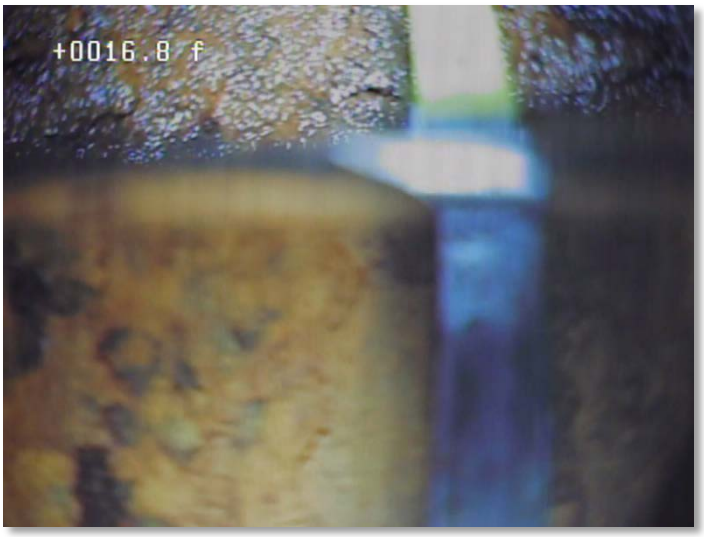
Figure 5: *Image from the video log showing the casing condition as it appears above and below the water level. This view, above and below the water level, illustrates the appearance of the casing as seen in the video log both in and out of water.*

Future consideration includes redeveloping the well to clear out the sediment accumulated at the bottom. This would improve the well's condition and should allow investigators to determine the casing depth as well as the aquifer type supplying this well. Following redevelopment we recommend performing a video log, a complete suite of geophysical logs, and a slug test.

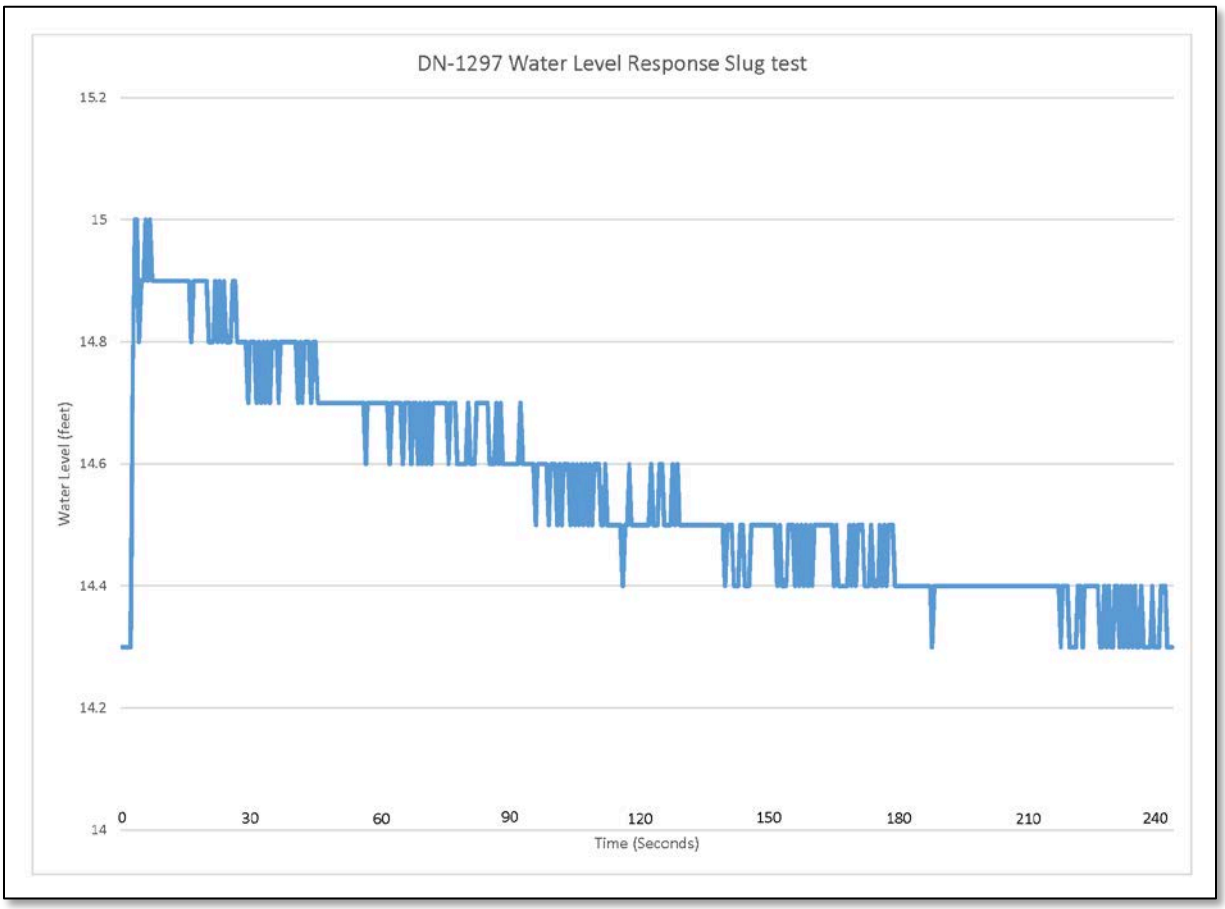
Figure 7: *Slug-in test data showing the recovery time of the DN-1297 well. The water level recovered after 4 minutes. Despite the lack of open hole and considering the only connection to the aquifer is through the sediment at the bottom of the hole, this well responded quickly.*

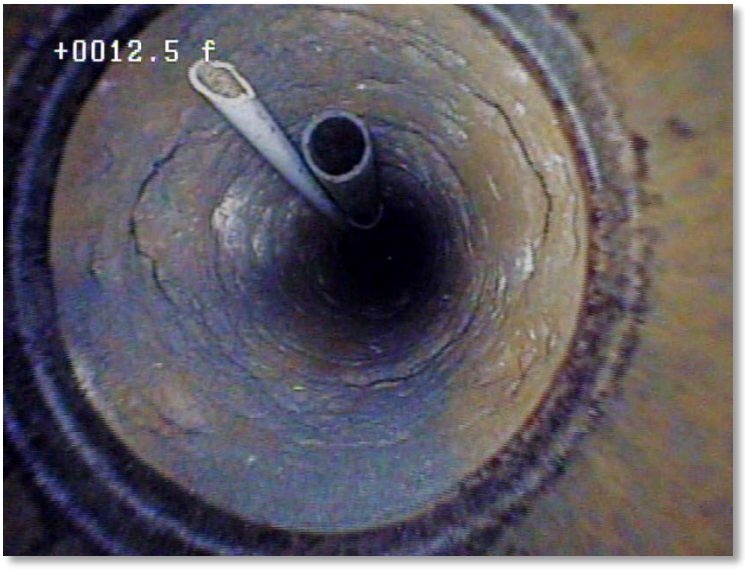
The video log was performed to get an idea of the condition of the well and determine the bottom depth. The video log showed that there are two pipes sitting in the well, a white plastic pipe and a larger diameter metal pipe (see video log photo in *figures 9 and 10*). The plastic pipe may have been used to push down on debris that clogged the well when it was vandalized in 1979 or possibly acted as an access to the well below the sediment. It is clearly broken, not cut. The metal pipe may have broken or been cut, it is hard to see. This well used to have a hand pump on it when it was used by the North Survey Schoolhouse, so the metal pipe may be an original pipe that fell to the bottom of the well.

Figure 9: *Video log image of the bottom of the casing with the two pipes sitting inside the well. The casing stops at 13.2 ft-bls and the pipes start at 13.4 ft-bls.*

Figure 10: *Video log image of the pipes under water which also shows staining on the borehole walls.*

Future work would be to remove the two pipes and redevelop the well by clearing the debris from the bottom of the borehole. Once the redevelopment work is completed it would be recommended to perform a video log, a complete suite of geophysical logs, and a slug test.

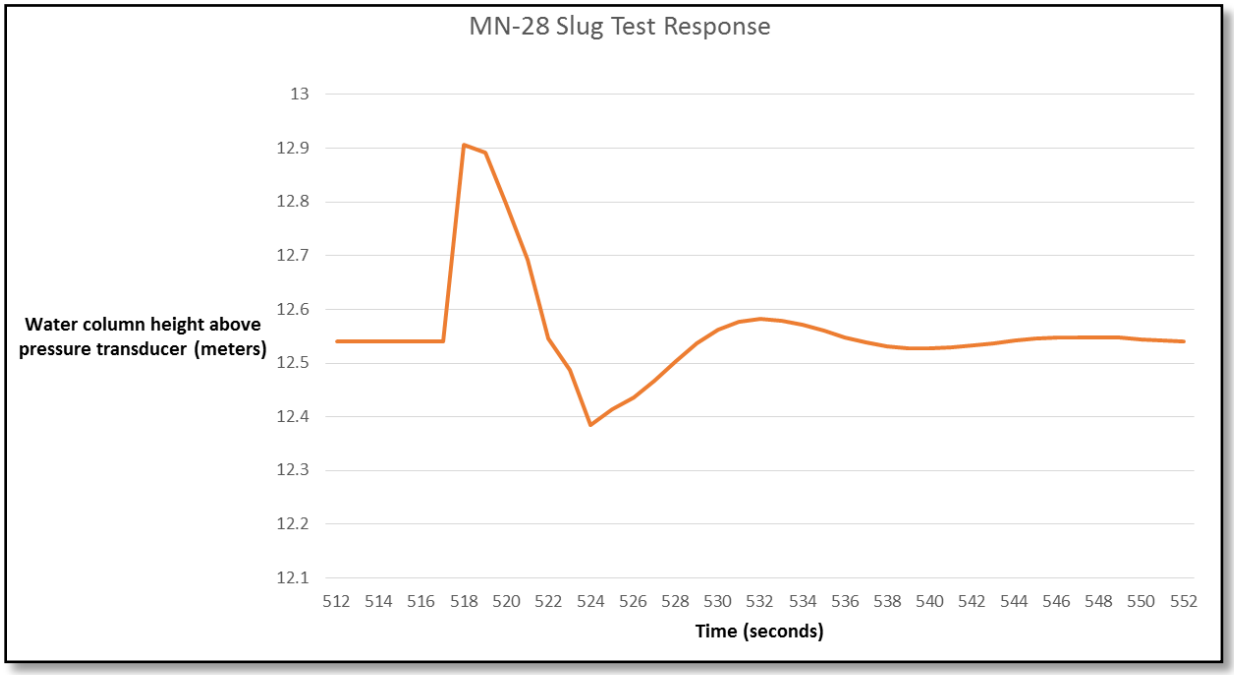
Figure 20: *Well initial response to the slug test. The well recovers within 35 seconds.*

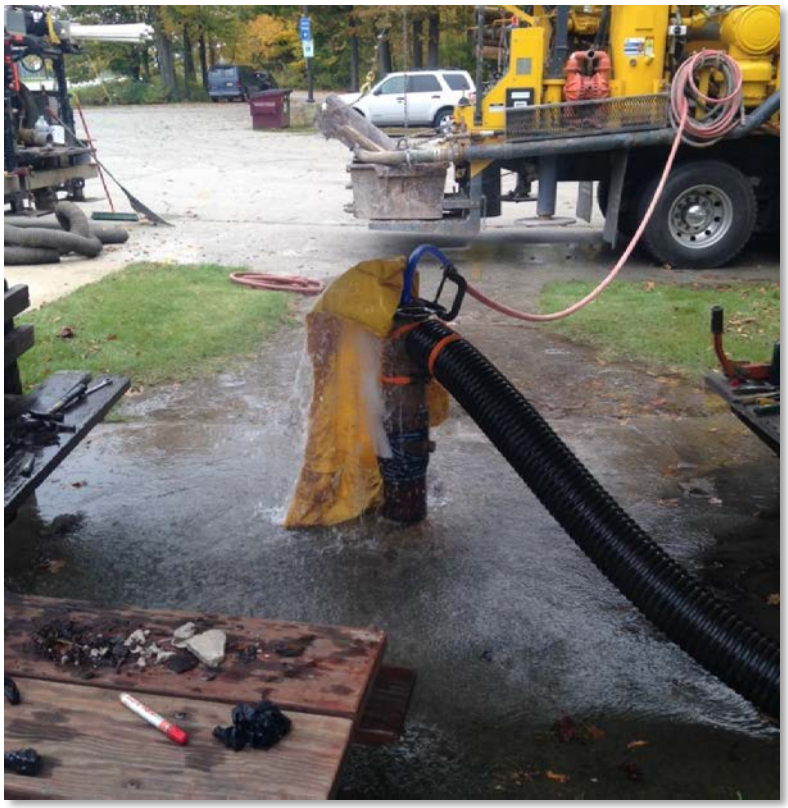
Figure 22: *Air lift process in action.*

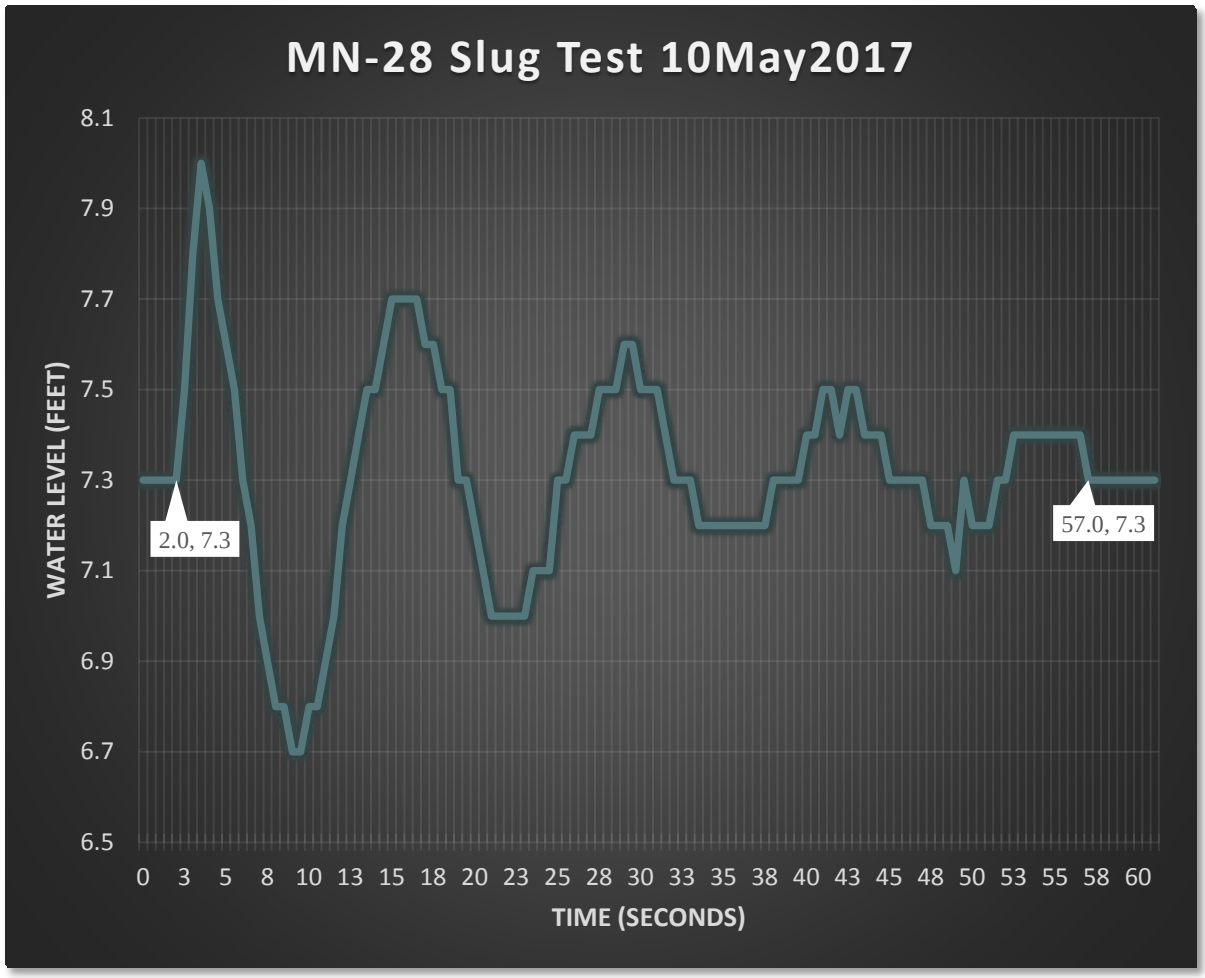
Figure 24: *Slug-in test results after redevelopment. This test had a 55 second recovery time after a 1.3 foot displacement. The depth to water was 24.4 ft.*

The WGNHS performed a video log and a final slug test on May 10, 2017. The slug test is shown above in *figure 24*. The final slug test shows an oscillatory response indicating a strong connection to the aquifer. The force of the slug entering the water causes the water level to raise in the hole and increases pressure at the water level.

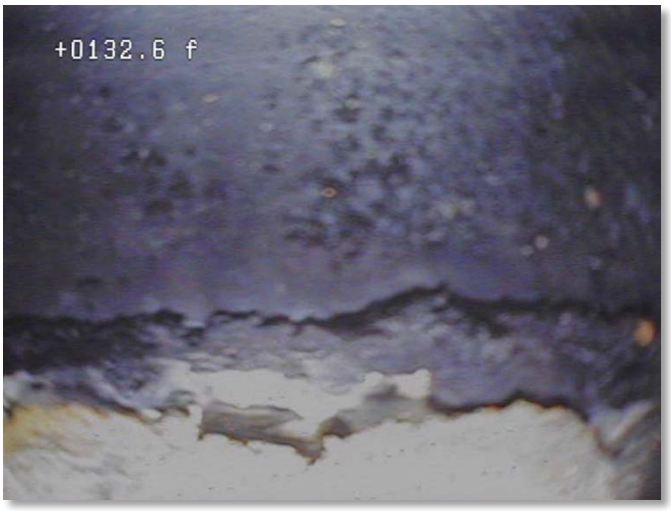
The video log shows a casing depth of 131 ft-bls in *figure 25*. In the image at the bottom of the casing there appears to be a bit of deterioration in the steel at the base of the casing, but there appears to be a solid contact and no open void space. This suggests the casing is well seated.

Figure 25: *Video image at the bottom of the casing.*

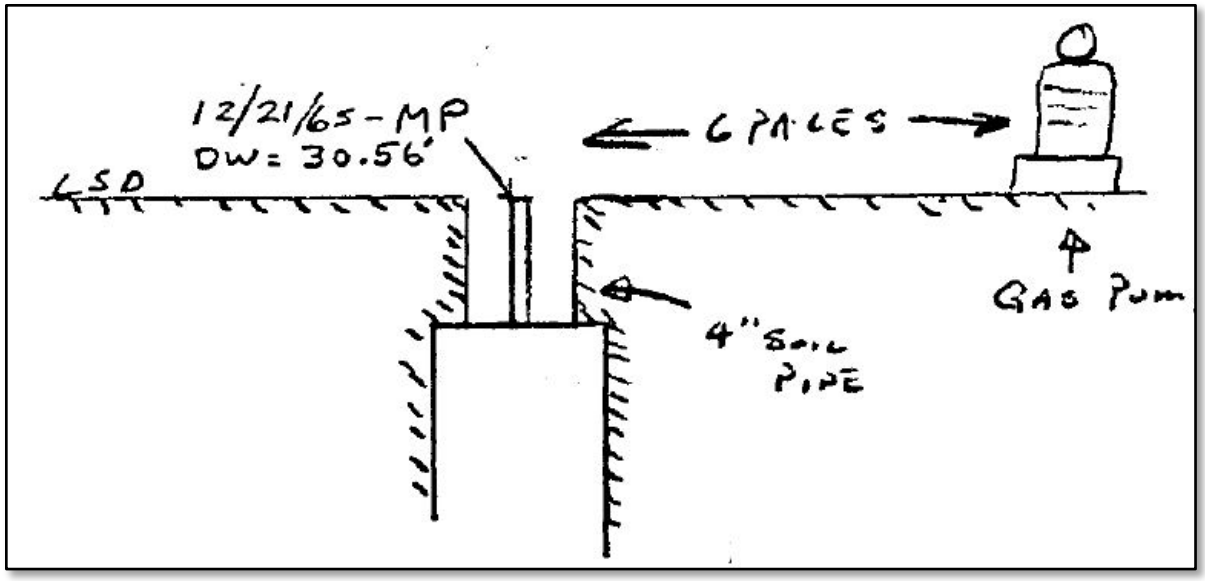
Figure 29: *Diagram of Small Diameter pipe installation from 1965.*

The historical records in conjunction with the visit to the site led to a decision that we should rehabilitate the existing well, rather than abandon it and replace it with a new boring. The WGNHS decided to remove the steel plate and the ¼ inch access port from the well, install a well casing extension, and a new protective flush-mount cover.

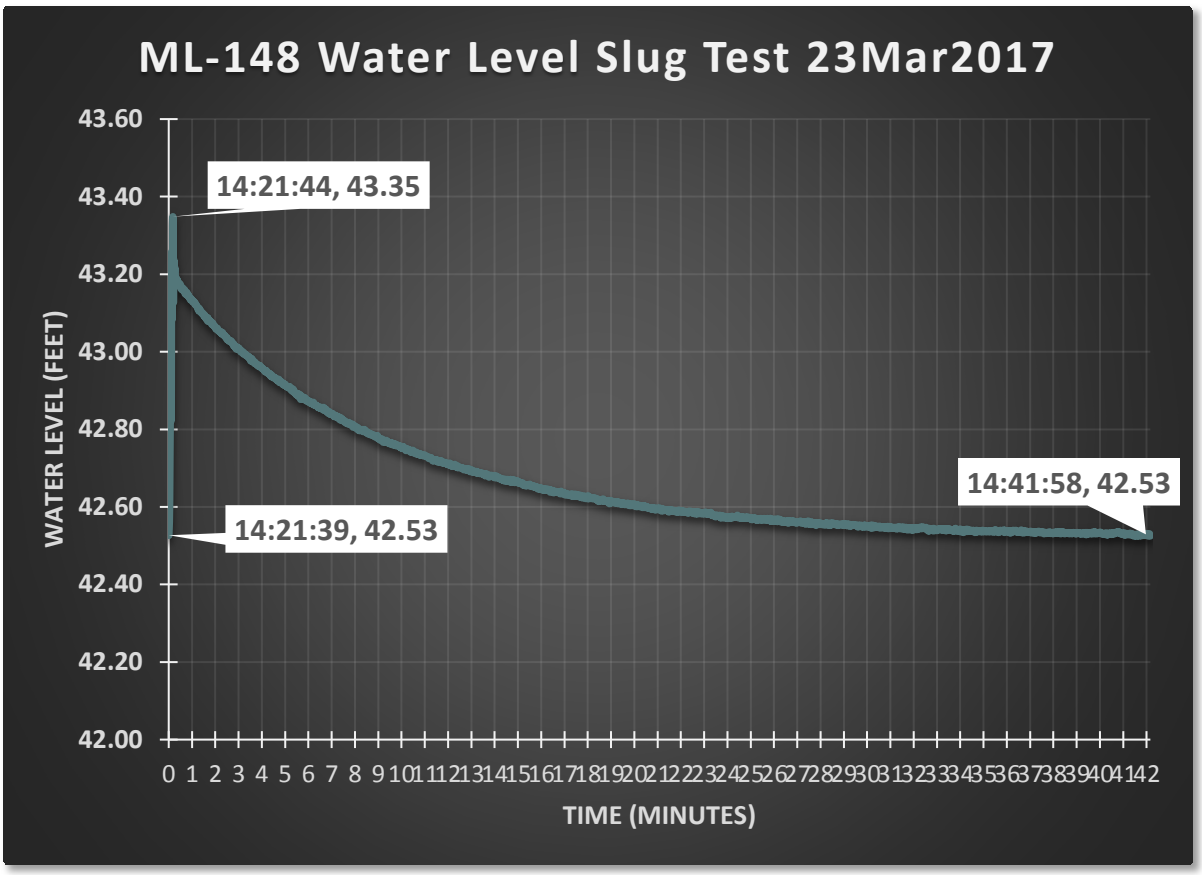
Figure 36: *Slug-in test results.*

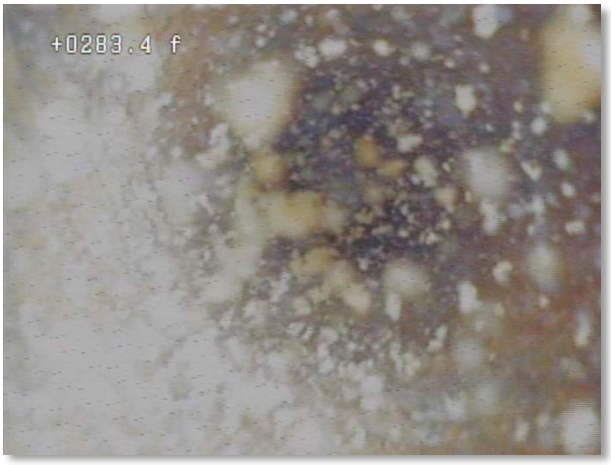
Figure 44: *Image from video log showing clay fouling at 281.3 ft-bls. The depth in the video is measured from the MP at the top of the casing.*

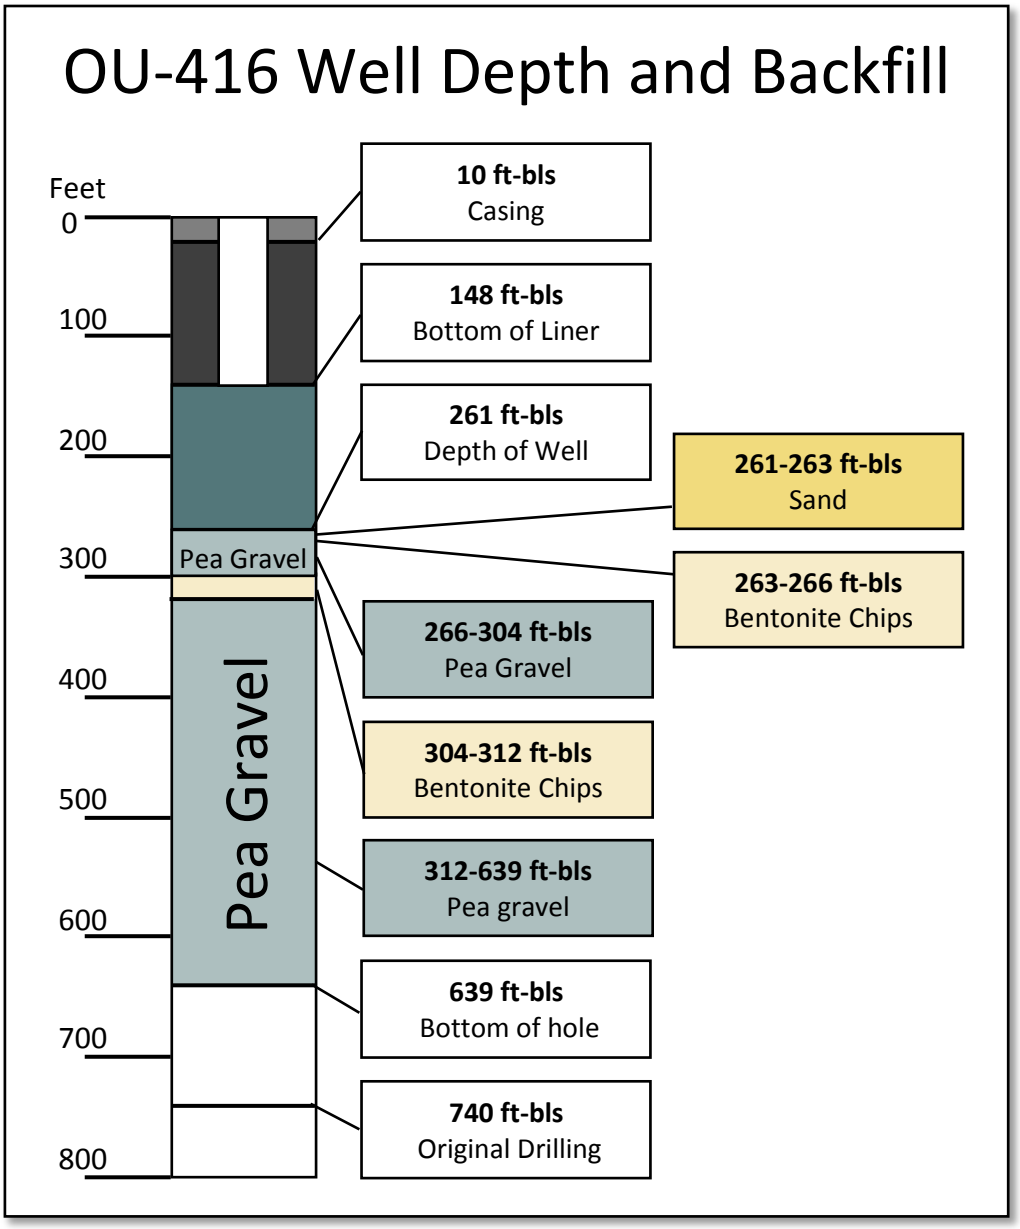
263-261 ft-bls Sand to help prevent bentonite expansion
266-263 ft-bls Bentonite chip layer
304-266 ft-bls pea gravel
304-312 ft-bls Bentonite chip layer
312-639 ft-bls pea gravel

Figure 45: *Diagram of well depth and backfill.*

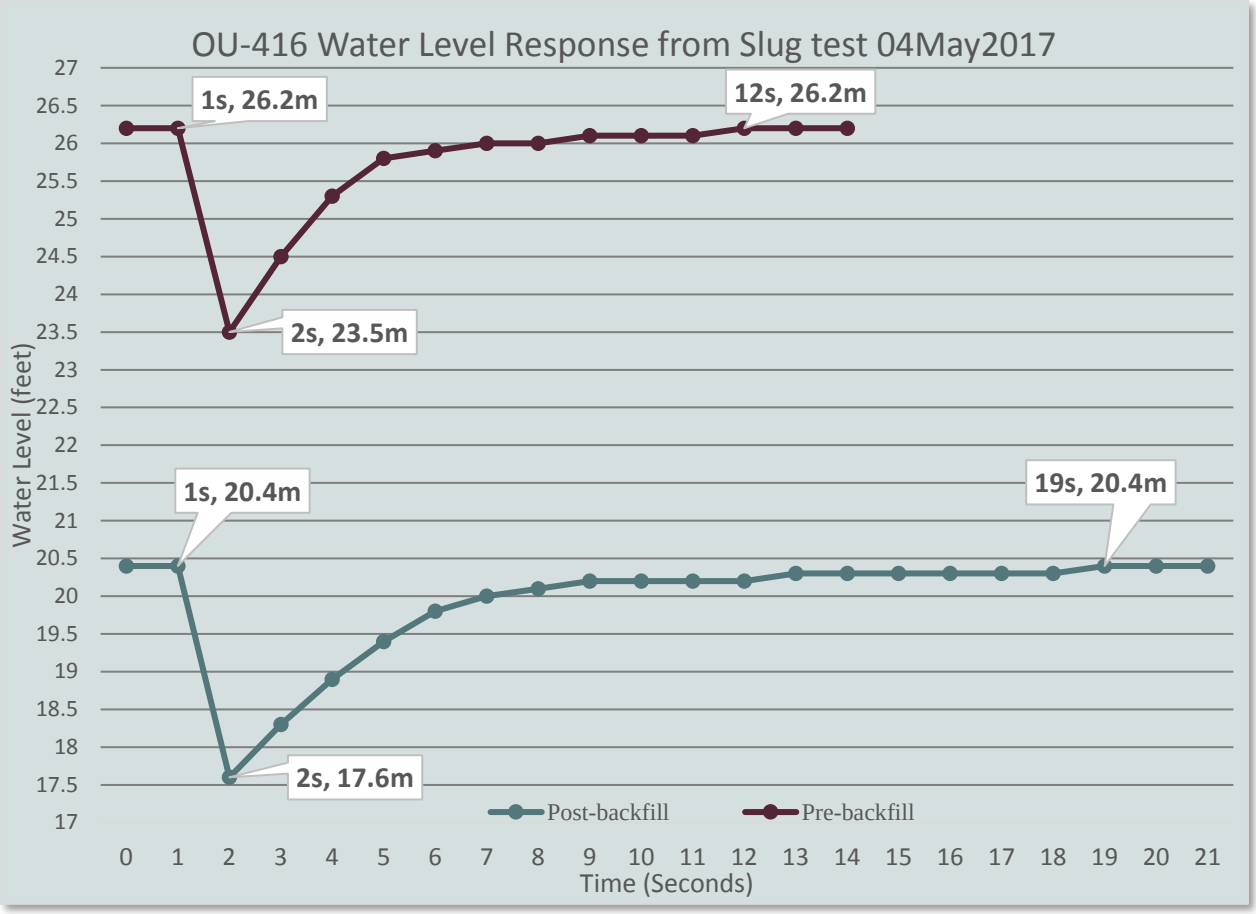
Figure 46: *Slug-out test results pre-backfill and post-backfill.*

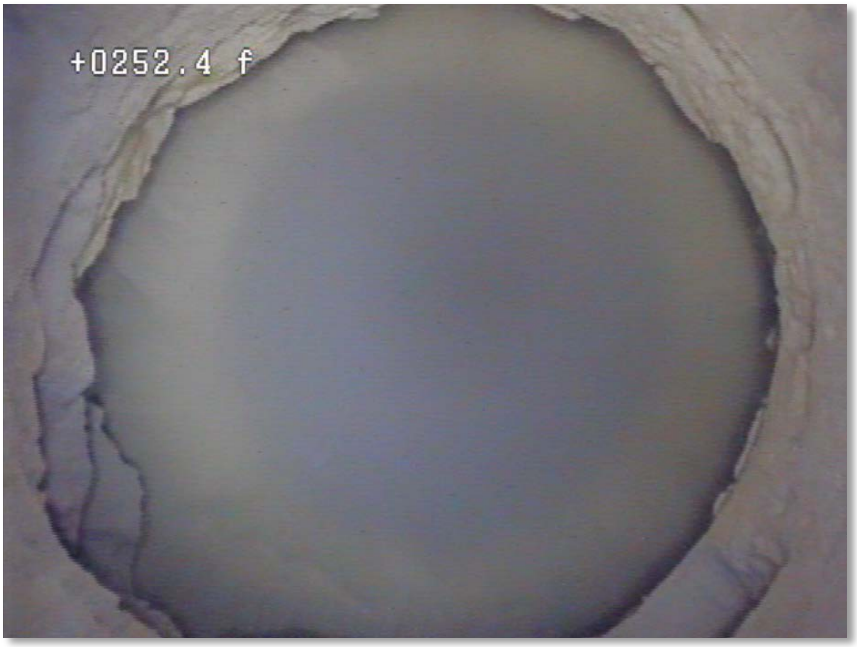
Figure 49: *Bottom of the well.*

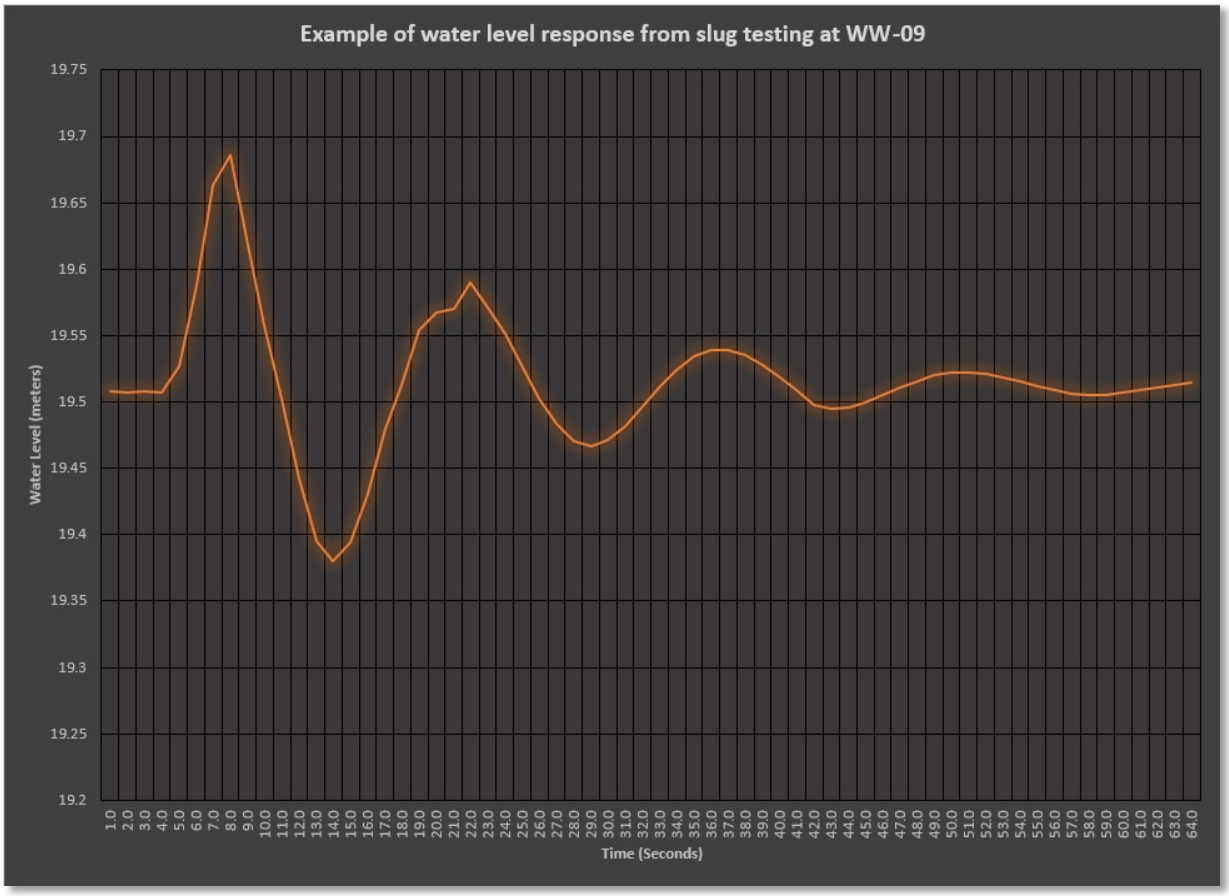
Figure 52: *Graph of slug-in test data.*
